OFFICE OF EXPERIMENT STATIONS—BULLETIN 240.

TIDAL MARSHES AND THEIR RECLAMATION.

GEORGE M. WARREN, .

WASHINGTON:
GOVERNMENT PRINTING OFFICE.
1911.

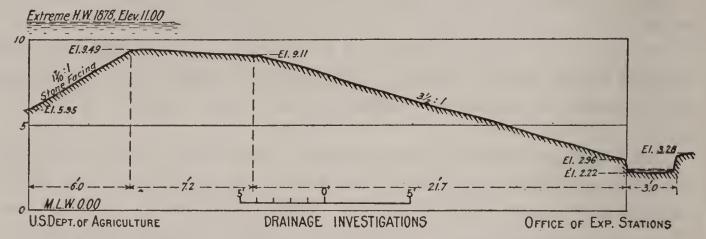
Fig. 4.—Cross section of levee near north end Colburn estate, Delaware City, Del.

The foundation of the levee is believed to the natural surface the marsh without other treatment than the cutting and removal of the vegetation upon it. The top and slopes have a good growth of grass but have not been kept sufficiently free from weeds, thus harboring burrowing animals. The condition facing in the stone places emphasizes the importance of suitable backing. Wave action, by removal of some of the fine material, has left spaces into which the stones have settled. As crushed stone or screened gravel would be too expensive for general use, it is believed that oyster shells would make excellent substitute. an These can be landed barges at the dock in Delaware City for $3\frac{3}{4}$ cents per bushel.

- (1) The top of the levee, 9 to 11 feet above mean low water, is below the storm tide of October, 1878, and has been reached in more recent years. It is unsafe. Its estimated cost, including sluice, is about \$6,900 per mile.

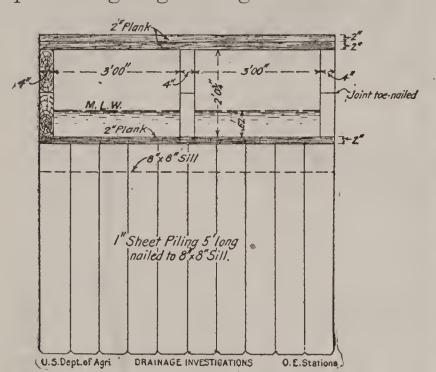
Fig. 7.—Cross section of sluice, Colburn estate, Deleware City, Del.

The sluice (see Pl. II, fig. 1) is of timber construction 51 by 7 feet, outside dimensions. Figures 6 and 7 show its construction in detail and its present grade. The gates are double thickness, 2-inch unmatched plank, have strap hinges and are unweighted. Near the center of each gate is an opening about 5 by 8 inches, fitted with copper slide working in horizontal copper grooves for admitting river water as needed during times of drought. Both gates seat poorly, permitting large leakage from the river. A strip is missing from the

bottom of the southerly gate, with the result that when closed there is an open space beneath its whole length, admitting large quantities of river water.

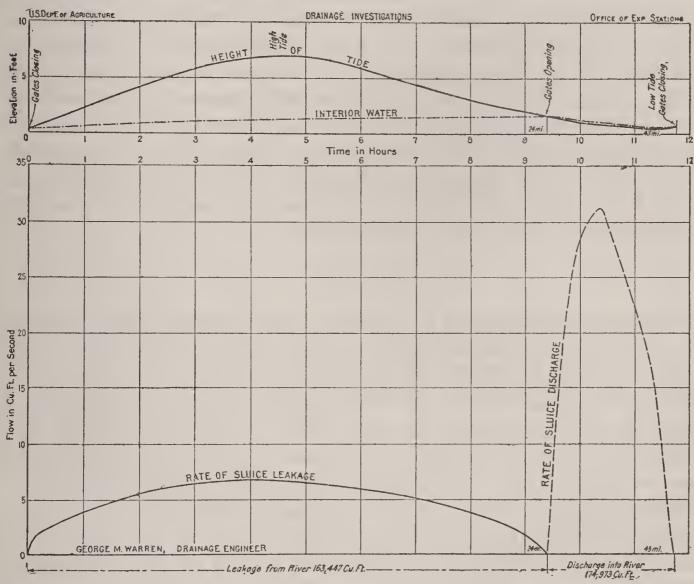
Fig. 8.—Diagram showing rise and fall of tide and ditch water and sluice leakage and discharge, Colburn estate, Delaware City, Del.

the corresponding moment. The leakage of September 2 and the discharge of August 6 are illustrated for the reason that on those dates the quantities measured approximately represent the normal workings of the sluice during the summer season.

The abnormal leakage of August 6 (249,480 cubic feet) was caused by the northerly gate becoming stuck for about one hour in a partially opened position. From gaugings of the ditch water covering a considerable period, it is very probable that the leakage of September 2 (163,447 cubic feet) is about the usual quantity. Taking the normal leakage between periods of sluice play as 163,447 cubic feet and the normal discharge as 168,347 cubic feet, it is seen that the former amounts to about 97 per cent of the latter. The difference in these quantities, 4,900 cubic feet, represents the amount of water which enters the land by seepage and percolation from the river, and by movement of the upland ground water, during a period averaging
